Recent landslides by natural geologic hazards in Hokkaido

Toshiyuki Kurahashi*, Satoshi Ishimaru**, Yoshihiko Ito*** (*Civil Engineering Research Institute; **Geological Survey of Hokkaido; ***Hokuden Integrated Consulting Service Co., Japan)

Heavy Rain and Landslide Disaster of July 2018 in Western Japan

Tomohiro Nishimura (Kokusai Kogyo Co., LTD)

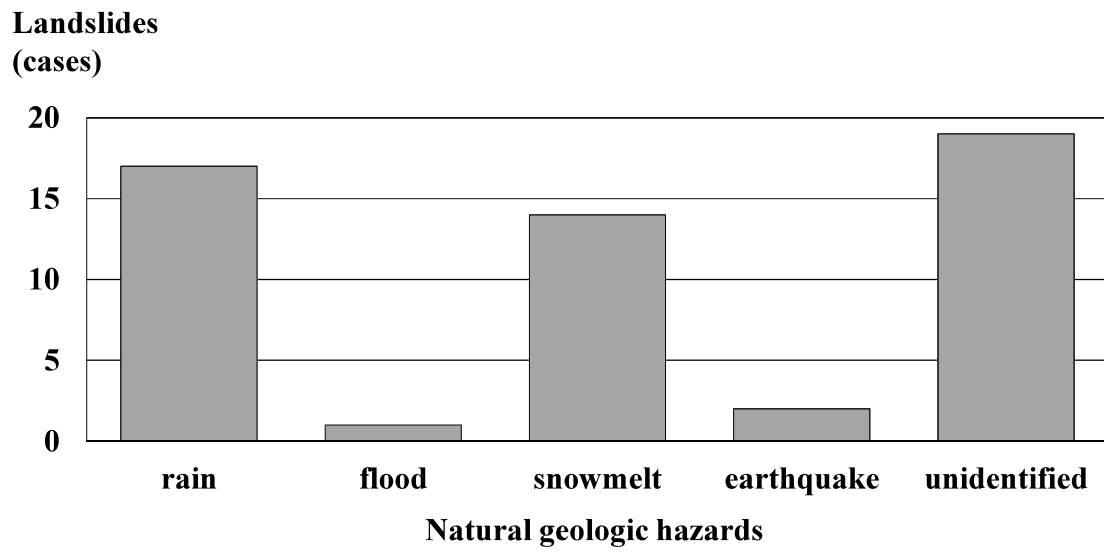
This report describes characteristics of landslides that were caused by natural geologic hazards during the last decade in Hokkaido. A geologic hazard is a geologic condition or phenomenon, natural or brought about by human activity, that represents a threat to human life, welfare and property (Neuendorf *et al.*, 2005). The natural geologic hazards are such conditions or phenomena which can lead to losses through landslides, floods, earthquakes, coastal and beach erosion, faulting and so on. Hokkaido had 53 cases of landslides by natural geologic hazards from 2008 to 2019 (figure 1). The hazards such as rain, snow-melt, earthquake and flood caused a lot of landslides.

figure 1. 59 cases of Landslides by natural geologic hazards in Hokkaido from 2008 to 2019.

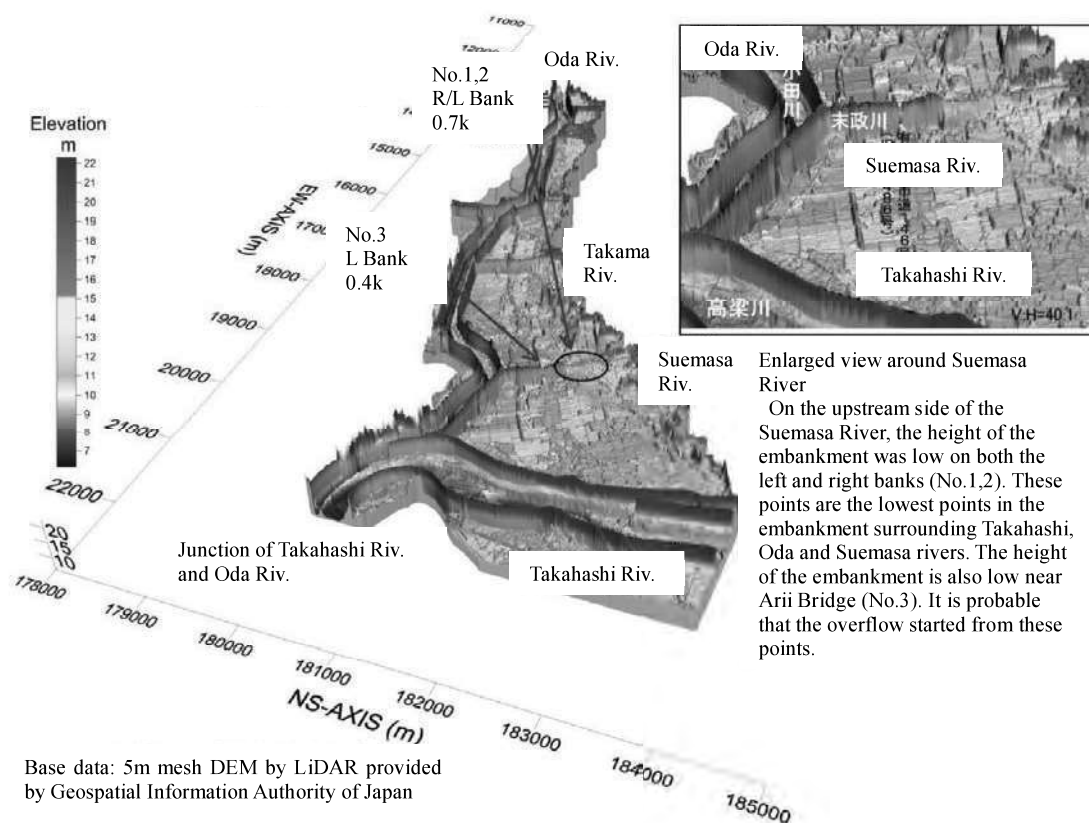
In Mabi-Town, Okayama Prefecture, a wide-area inundation disaster occurred downstream of the Oda River in the Takahashi River system. In the area where the inundation damage occurred, the changing of land use in about one century was clarified, and the state of transmission of past disasters records were investigated. And, by analyzing DEM data by LiDAR, topographical features such as differences in the height of the river embankment where overflowed or destroyed, and flooded areas were clarified (Fig. 1). In addition, we interviewed many residents about the inundation start time and showed how the inundation progressed on time line.

Fig.1 Bird view around the junction of Takahashi River and Oda River
