Document number	SCJ 23 th term -290214-23551300-056
Committee name	Science Council of Japan Sub-Committee on Fukushima Nuclear Accident Comprehensive Synthetic Engineering Committee
Title	Reflections and Lessons from the Fukushima Nuclear Accident (Second Report)
Date	2017 .02.14

Reflections and Lessons
from
the Fukushima Nuclear Accident
(Second Report)

Working Group on Fukushima Nuclear Accident
Sub-Committee on Fukushima Nuclear Accident
Comprehensive Synthetic Engineering Committee
Science Council of Japan

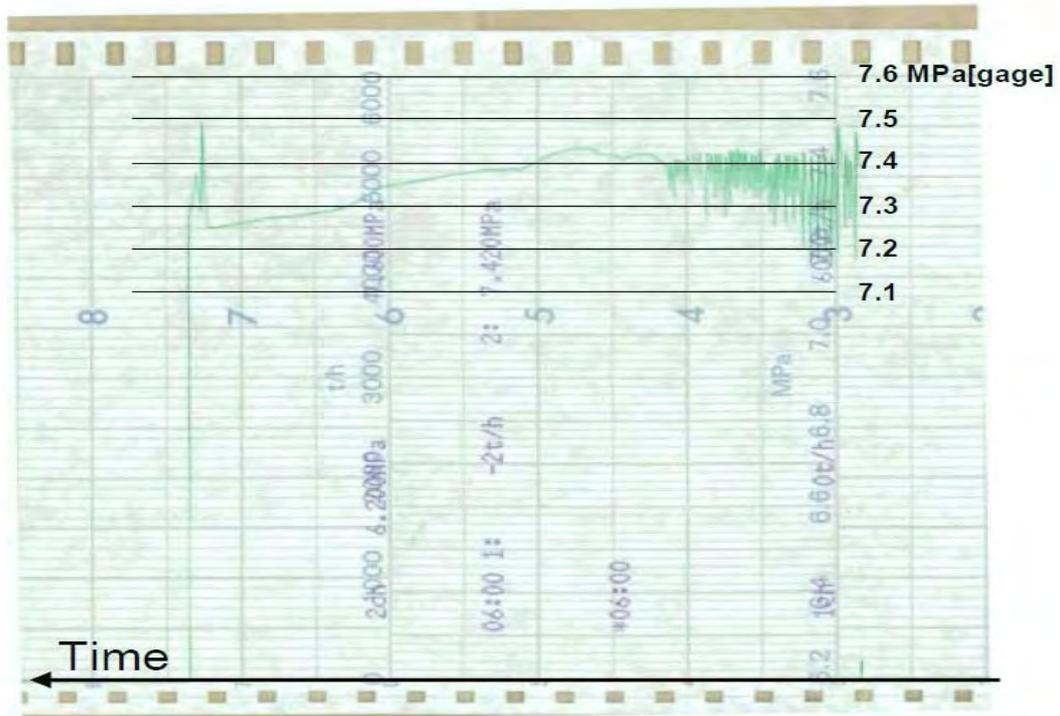
Fig. A10-1 Chart of the reactor pressure (narrow band)

The Government report [A10-2] pointed out that the decompression itself could be due to the failure of the pressure boundary of the reactor coolant system. But in TEPCO we think, through the consideration done in the above report [A10-1], that it is not the failure of the pressure boundary but it could be the decompression because the automatic decompression system worked.

We estimate that the leakage occurred as the accident progressed. But we could not estimate the definite time when the leakage started using the measured change of the pressure since the RPV had been decompressed.

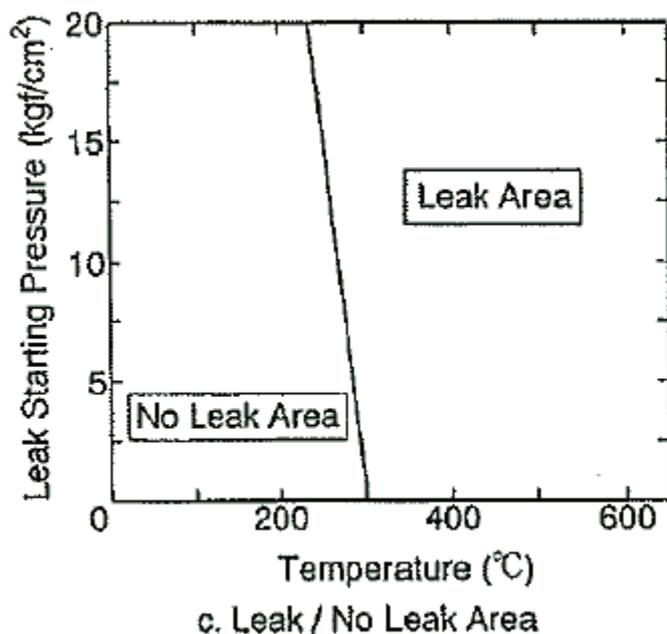
Fig. A10-2 The relation between the pressure and the heatproof temperature of the silicone rubber. [A10-3]

As the sealed parts, there are the top head flange, hatches for the devices and air locks. O-rings made of silicone were used for each. Fig. A10-2 shows the heatproof temperature for silicone rubber. This figure was obtained through past research where the PCV was modeled by a small model device and the relation between the pressure and the heatproof temperature was obtained. The figure shows that the heatproof temperature decreases with increase of the pressure and that it ranges from 225 to 300°C within the pressure range below 20 kgf/cm².
