The 8th Conference of the Science Council of Asia (SCA)
Qingdao, May 28-30, 2008

Earthquake and Tsunami Damage Survey in Indonesia and Recommendation for the Reconstruction

Hirokazu IEMURA
Kyoto University, Professor

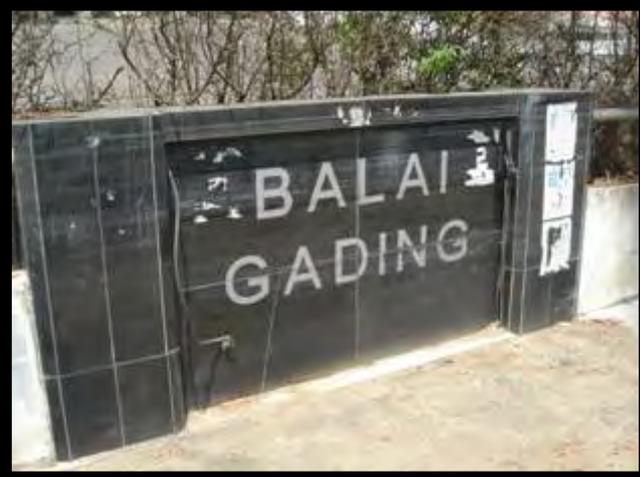
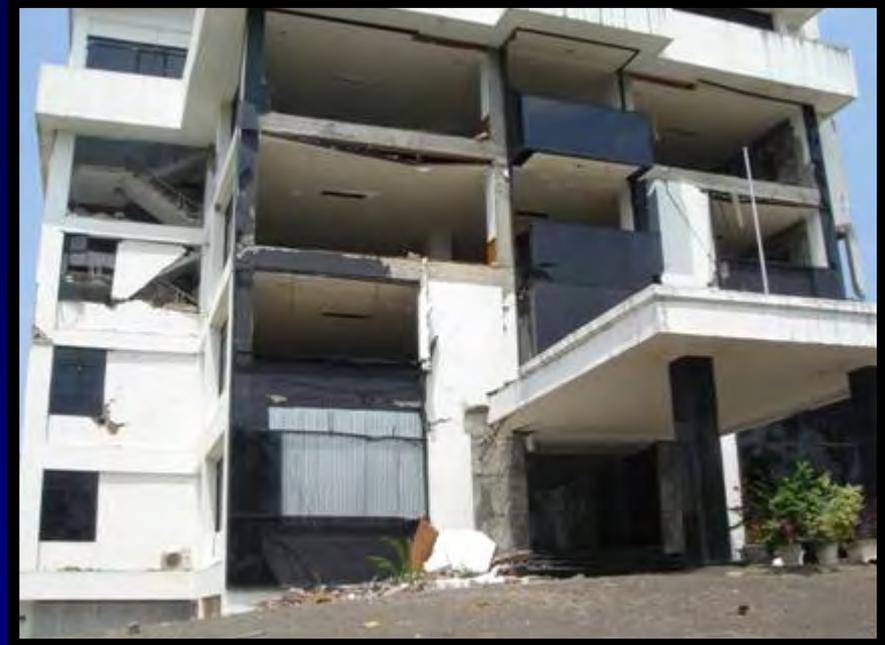
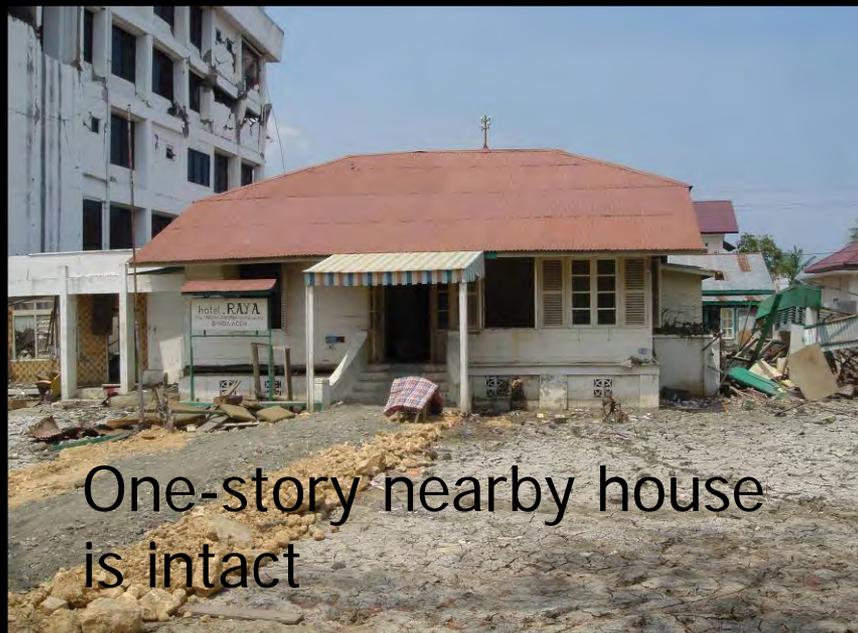
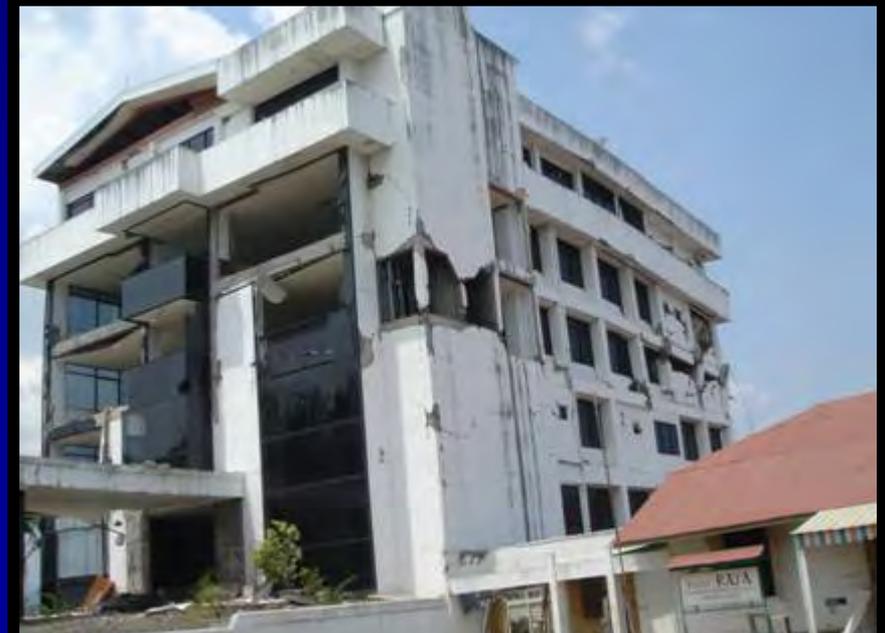
Nearby Buildings

One-story nearby house is intact

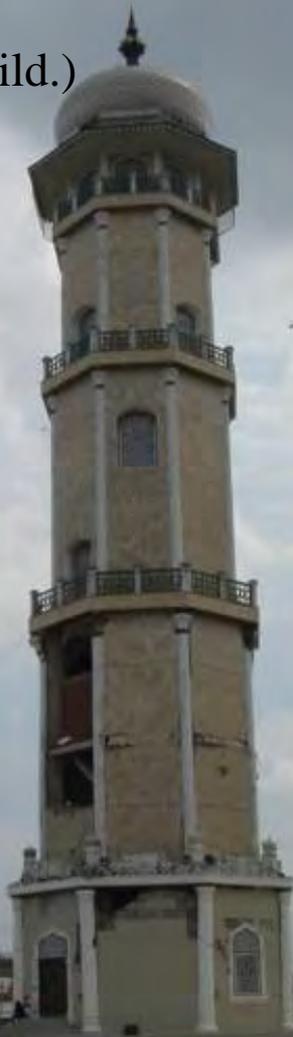
Main Tower
(east of main build.)

Tsunami
flood about
80 cm

- Relatively large scale modern buildings, water tanks, and mosque tower suffered severe damage due to long period component of ground motion
- Seismic design of these structures has to be carefully reviewed

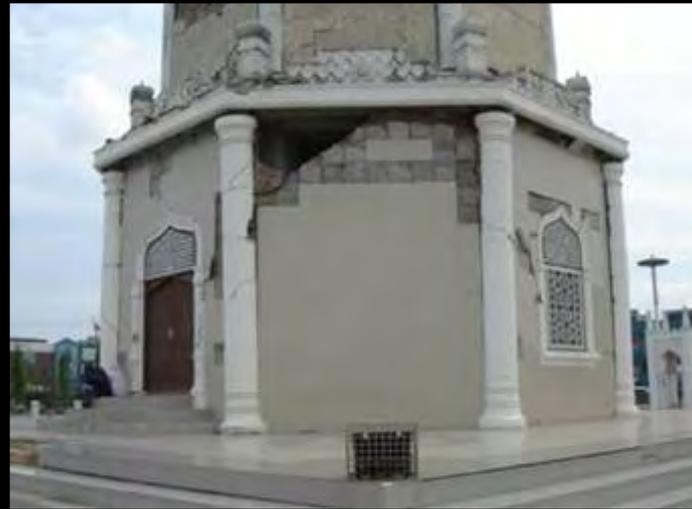
Severe
cracking
and spalling
of concrete

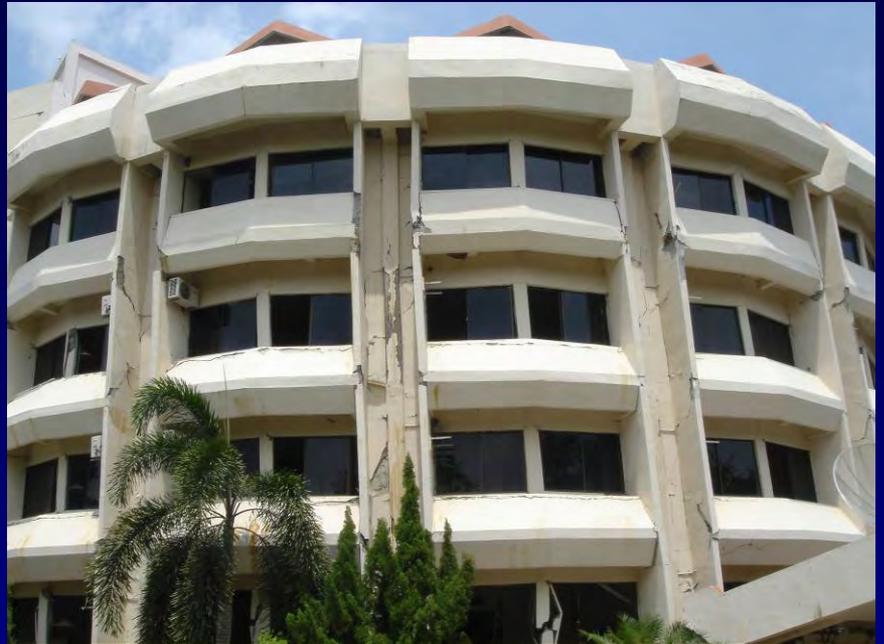
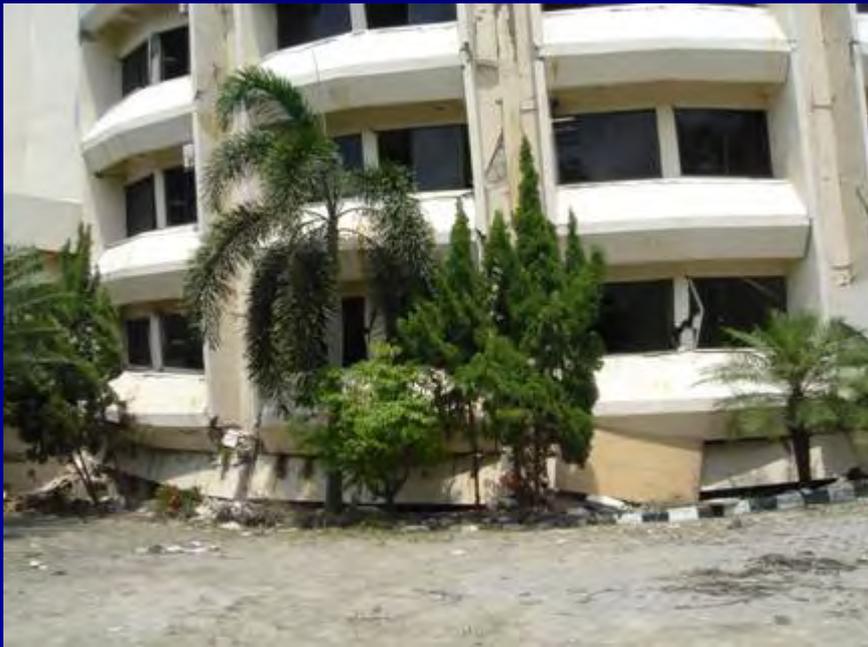
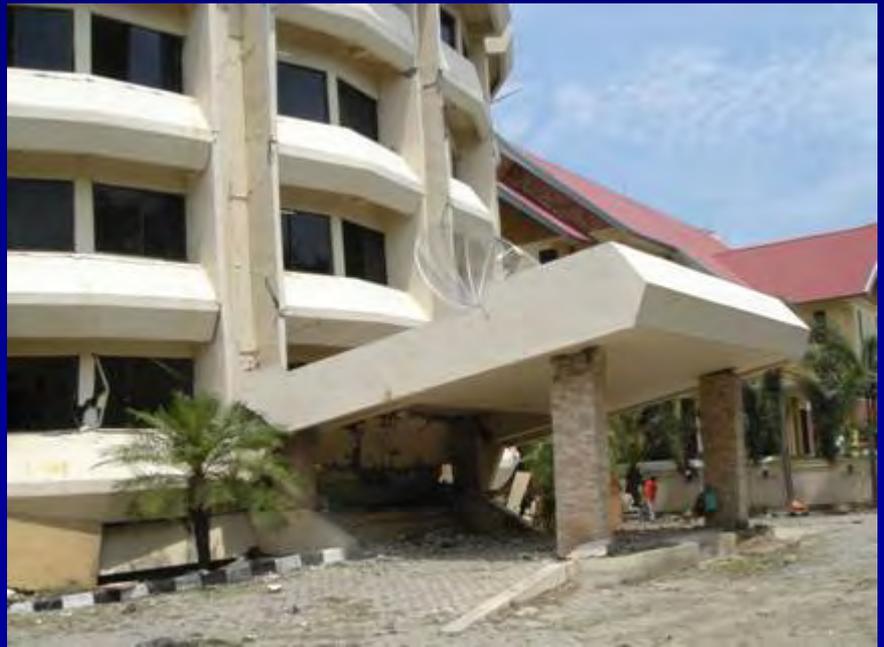
Nearby Buildings March 02, 2005 (Kuala Tripa Hotel)

The hotel was expanded from a
4-story hotel to a 5-story hotel

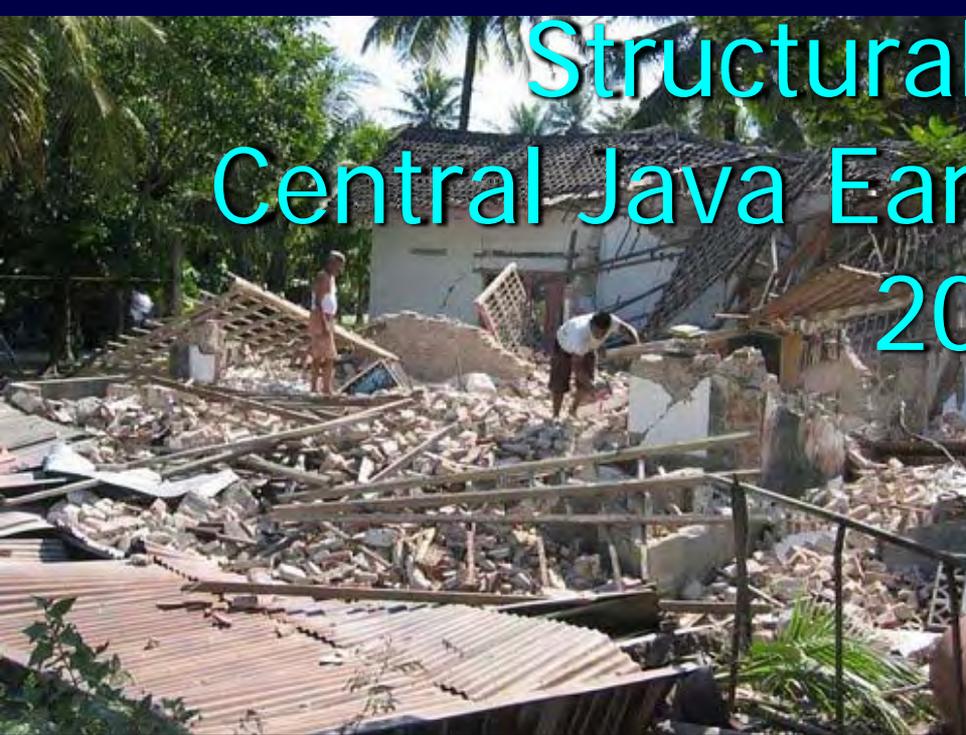
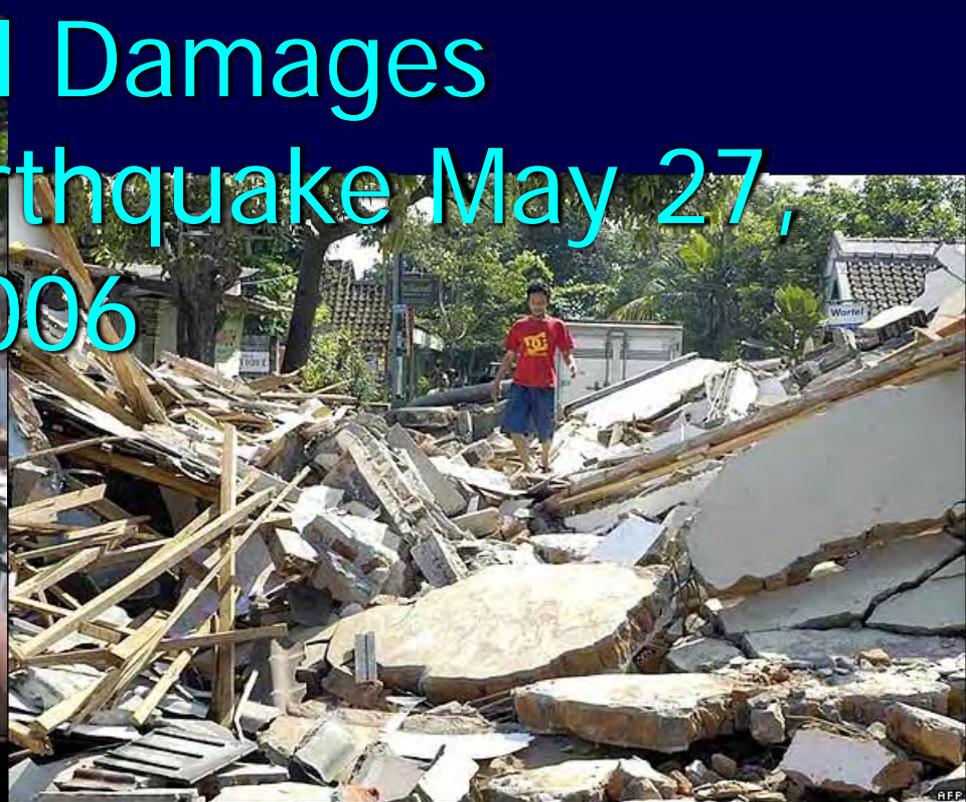
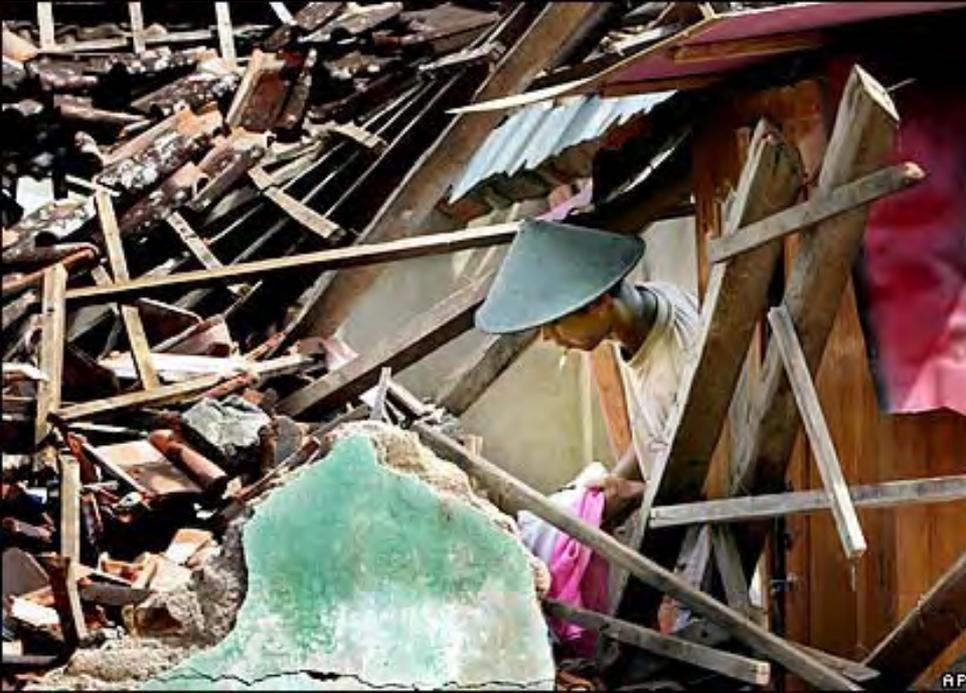
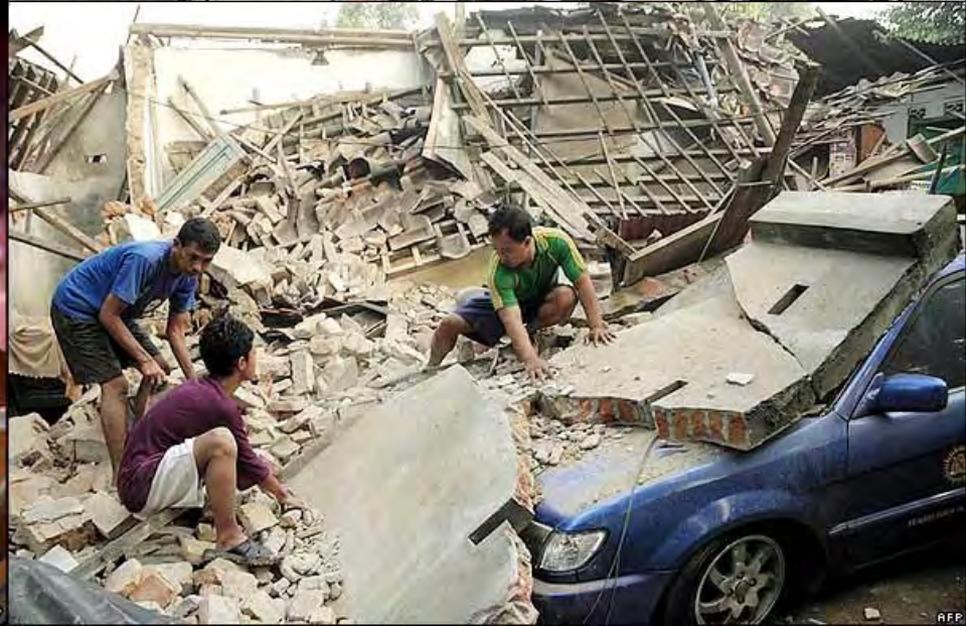
Structural Damages Central Java Earthquake May 27, 2006

- Non-engineered adobe or redbrick houses are severely damaged
- Seismic intensity is not high and differs a lot depending on the locations

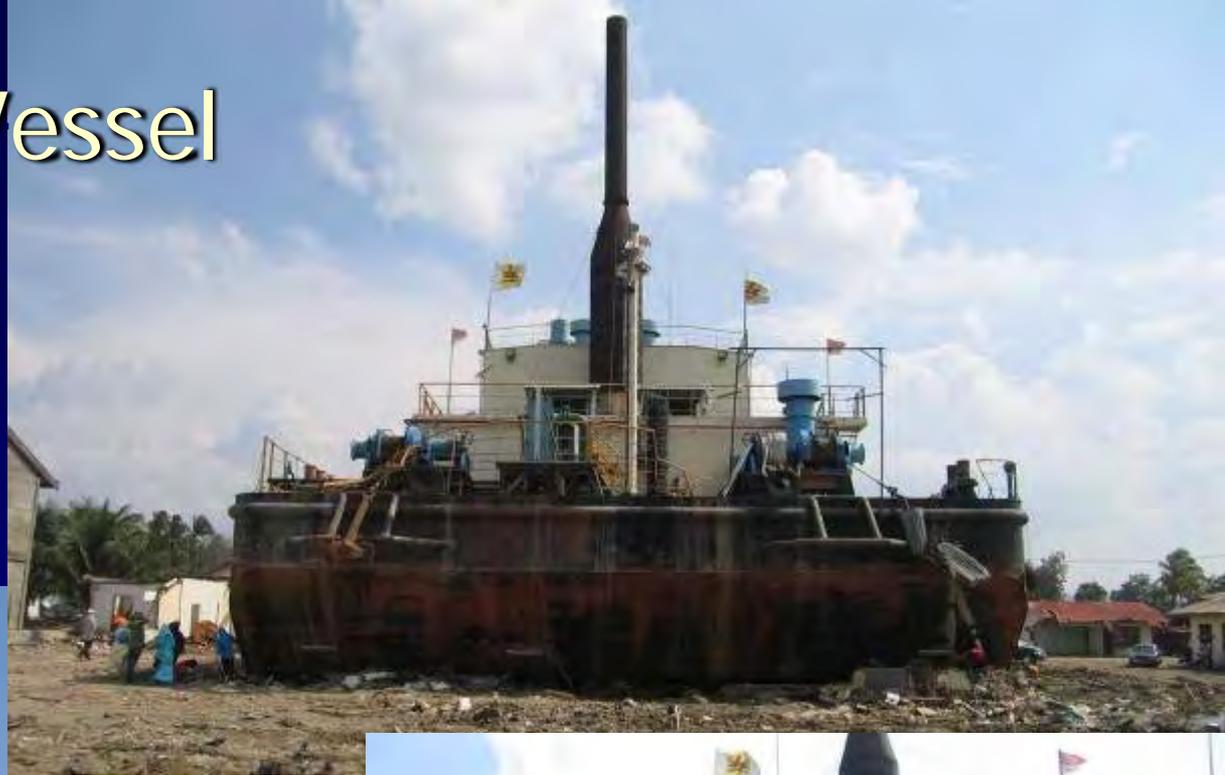
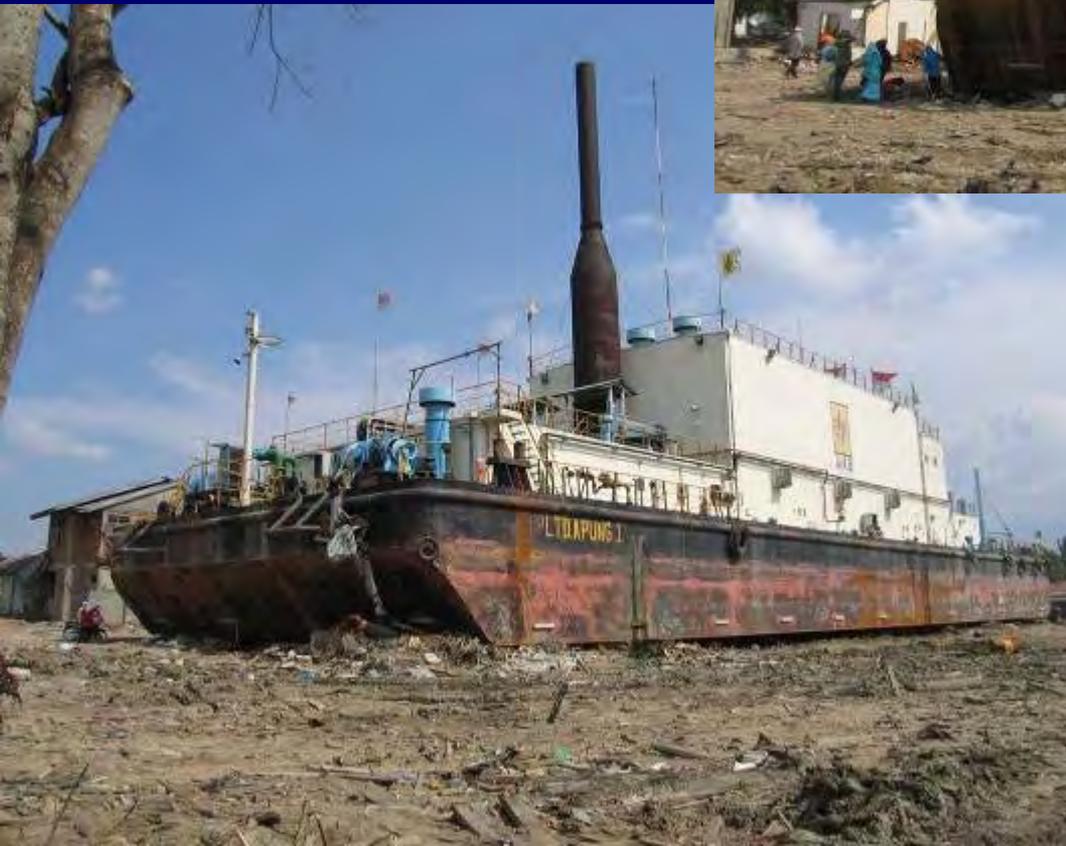
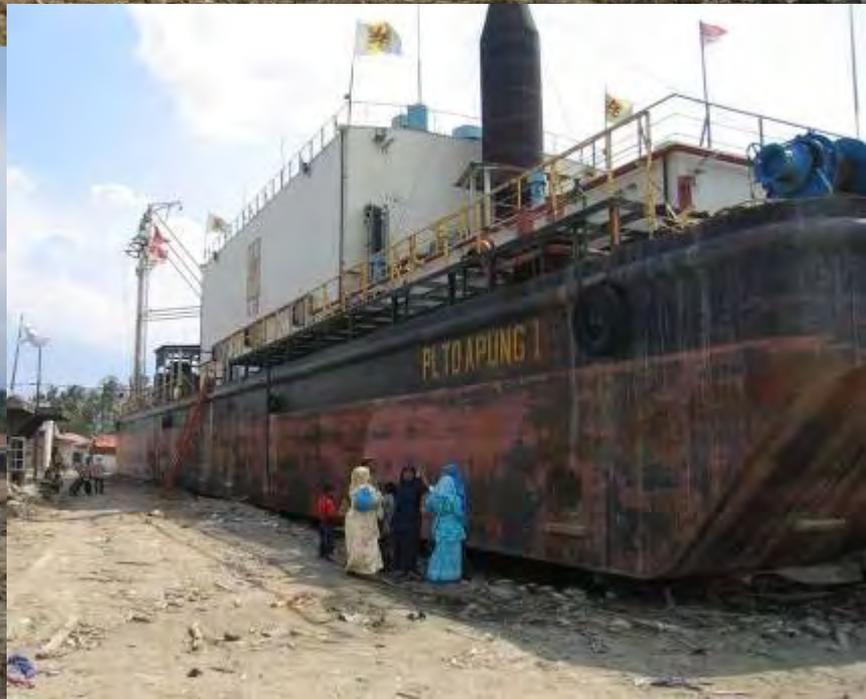
Electric Plant Vessel

600トンの船が津波により3キロ内陸部へと流された
