Safeguarding Quality of Life: Research Needs for Condition Assessment and Collapse Quantification of Building and Infrastructural Systems

**Masayoshi Nakashima
Disaster Prevention Research Institute (DPRI)
Kyoto University**

Today's Topics

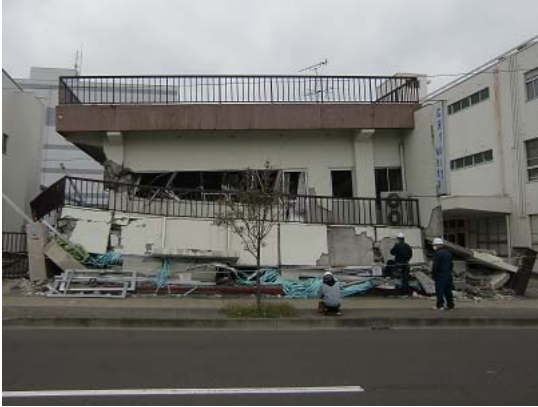
**Collapse of First Story
in Two-Story RC**

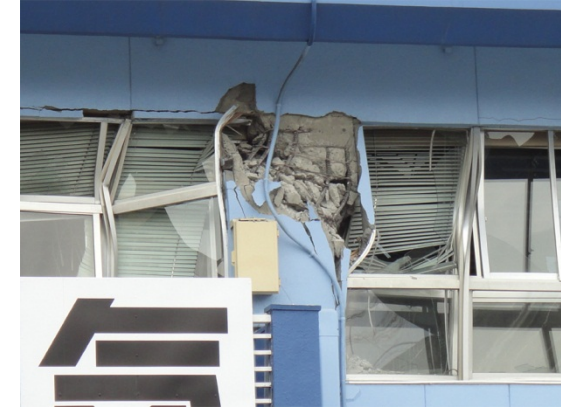
**Shear Failure of RC
Columns**

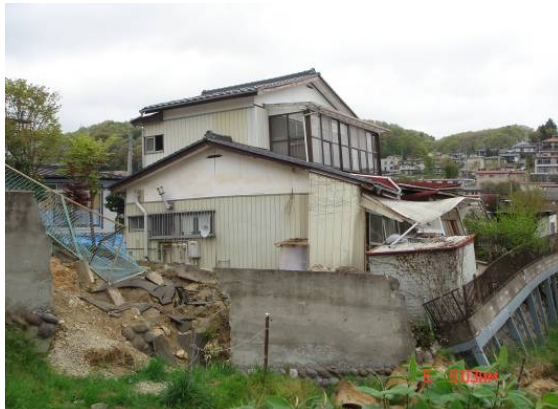
Failure of House by Landslide

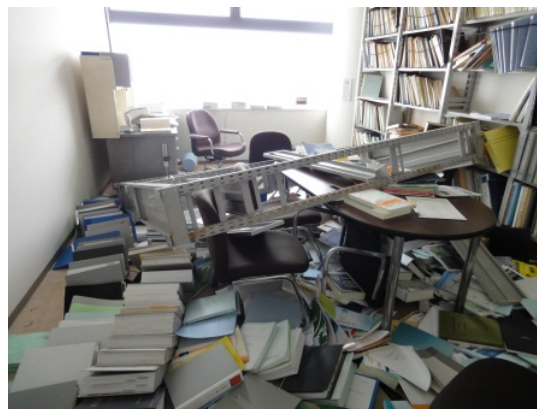
Nonstructural Damage

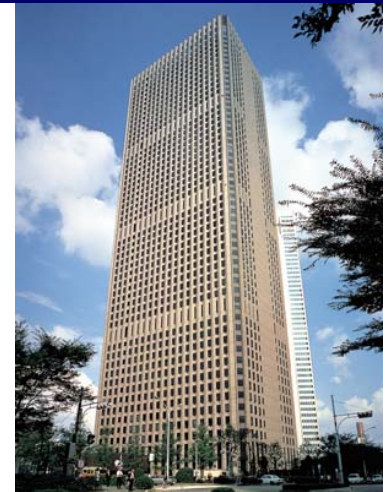
Effect of Retrofit:

Disp. → about 20% reduction

Acc. → about 30% reduction

Decay after quake → about 50% reduction

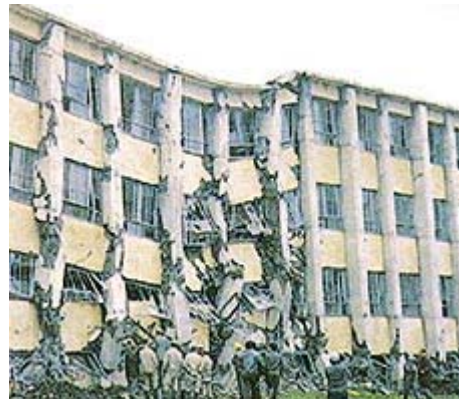
**RC Shear
Failure**

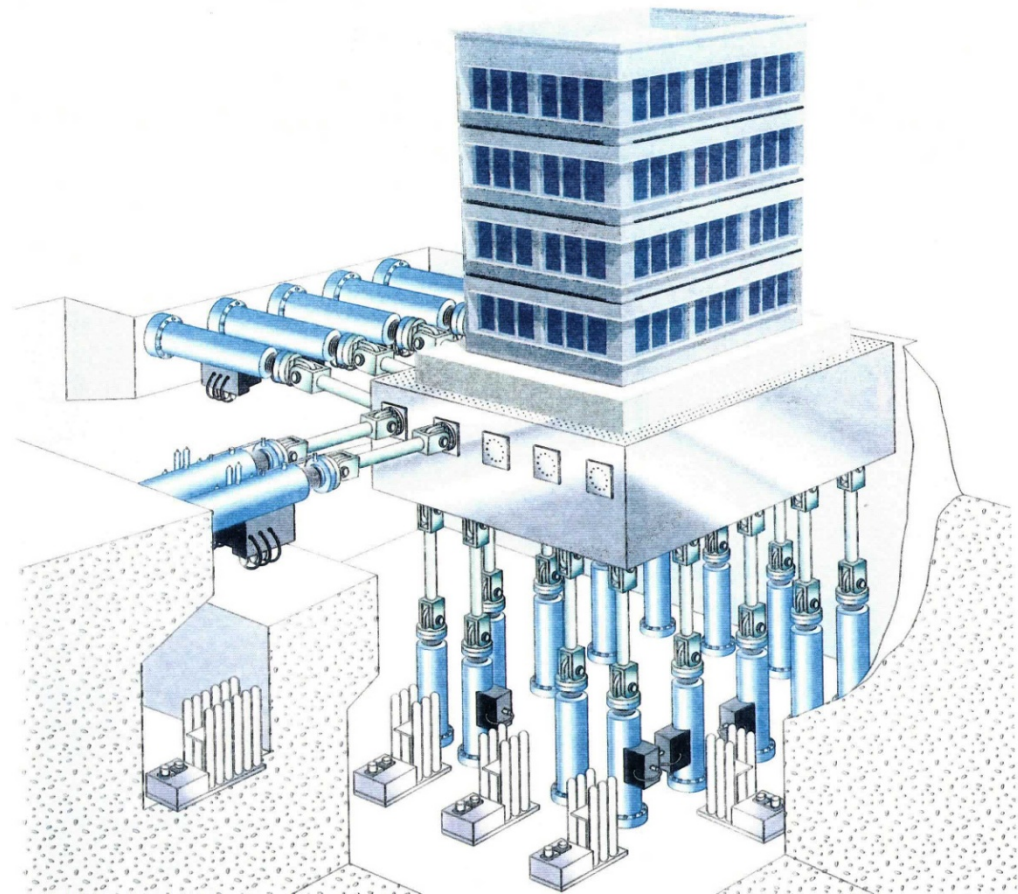
How are we able to produce pseudo-actual damage? – “very large-scale (or realistic-scale) tests,” “tests using actual ground motions,” and “tests on entire structure (rather than members and elements)” is a solution.

The tool on the right may be used to this end.
