Mid- and long-term roadmap and action plan for decommissioning of the reactors #1 to 4 of the TEPCO Fukushima Dai-ichi Nuclear Plant3

Oct 10, 2013

Tokyo Electric Power Company

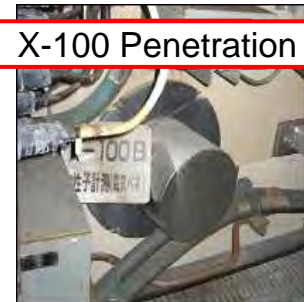
PCV Investigation

➤ PCV investigation with CCD camera (2012/10)

⇒ Water Level: Approx. 2,800 mm + PCV Bottom
 Water Temperature : Approx. 35 deg C

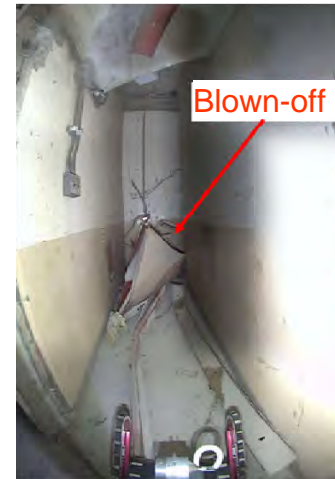
Robot Survey in the TIP room

- Robot survey in the TIP room in the Reactor Building (2012/3)
 - Water level measurement in Torus Room(2012/6, 7)
- ⇒ Torus Room Water Level : Approx. OP 3,370

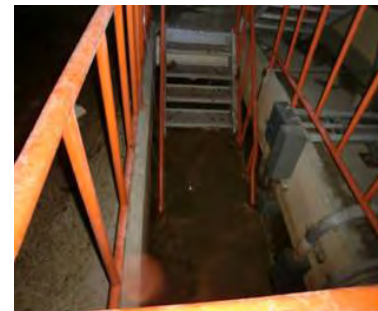
Water Level Survey in Torus

Northwest staircases area

Water Level
Torus Room	OP 3370
Staircase area	OP 3150

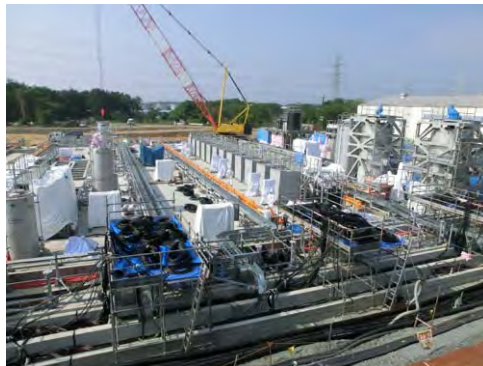
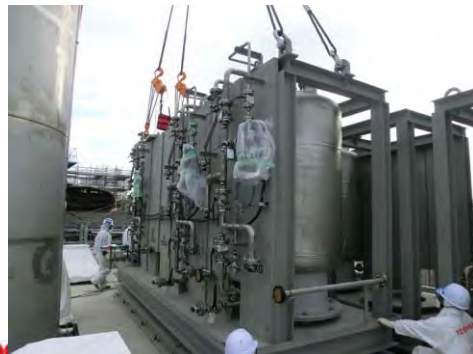
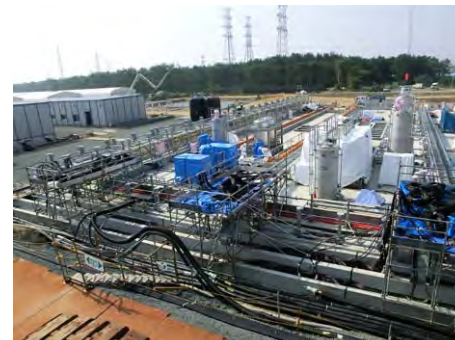
Multi-Nuclides Removal Equipment

- Treatment Water by
- ① Desalination sys
 - ② Cs absorption sys

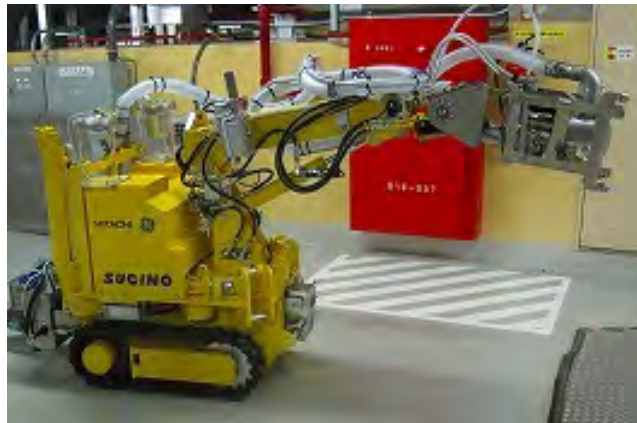
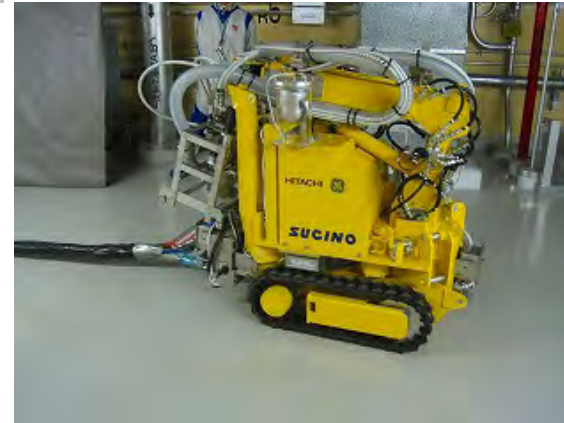
Building internal decontamination (High water pressure Decontamination device)

Mechanical decontamination of surfaces by spraying high-pressure water on objects of decontamination.

Concrete services can be ground down by increasing the pressure.

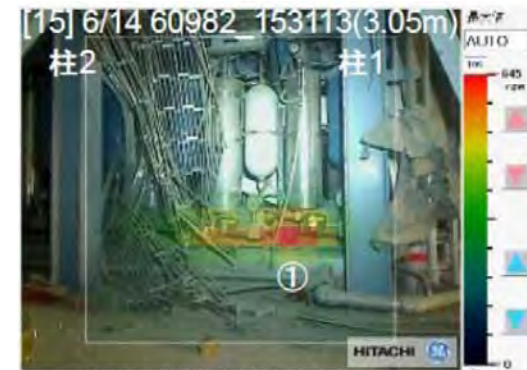
Radiation source survey(γ camera) results example (Unit 3 South side HCU)

- Dose rate survey results
 - Unit 1: 3.2~8.9mSv/h
 - Unit 2: 6.8~30.3mSv/h
 - Unit 3: 15.8~124.7mSv/h
- Radiation source survey results
 - the primary hotspots are containment vessel penetration seals, water pressure control units (HCU) and the Unit 3 equipment hatch railing

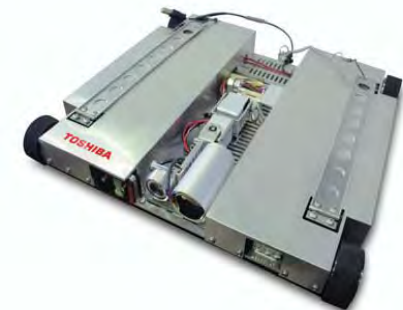
Small running car

313mm(L) × 327mm(W) × 47mm(H)

- Specific locations within the torus can be accessed using the quadruped robot
- After being put in position a small running car attached to the end of the quadruped robot arm will be affixed to the top part of the S/C and moved near the vent pipe in order to take pictures and record sounds.
