Document number	SCJ 23 th term -290214-23551300-056
Committee name	Science Council of Japan Sub-Committee on Fukushima Nuclear Accident Comprehensive Synthetic Engineering Committee
Title	Reflections and Lessons from the Fukushima Nuclear Accident (Second Report)
Date	2017 .02.14

Reflections and Lessons
from
the Fukushima Nuclear Accident
(Second Report)

Working Group on Fukushima Nuclear Accident
Sub-Committee on Fukushima Nuclear Accident
Comprehensive Synthetic Engineering Committee
Science Council of Japan

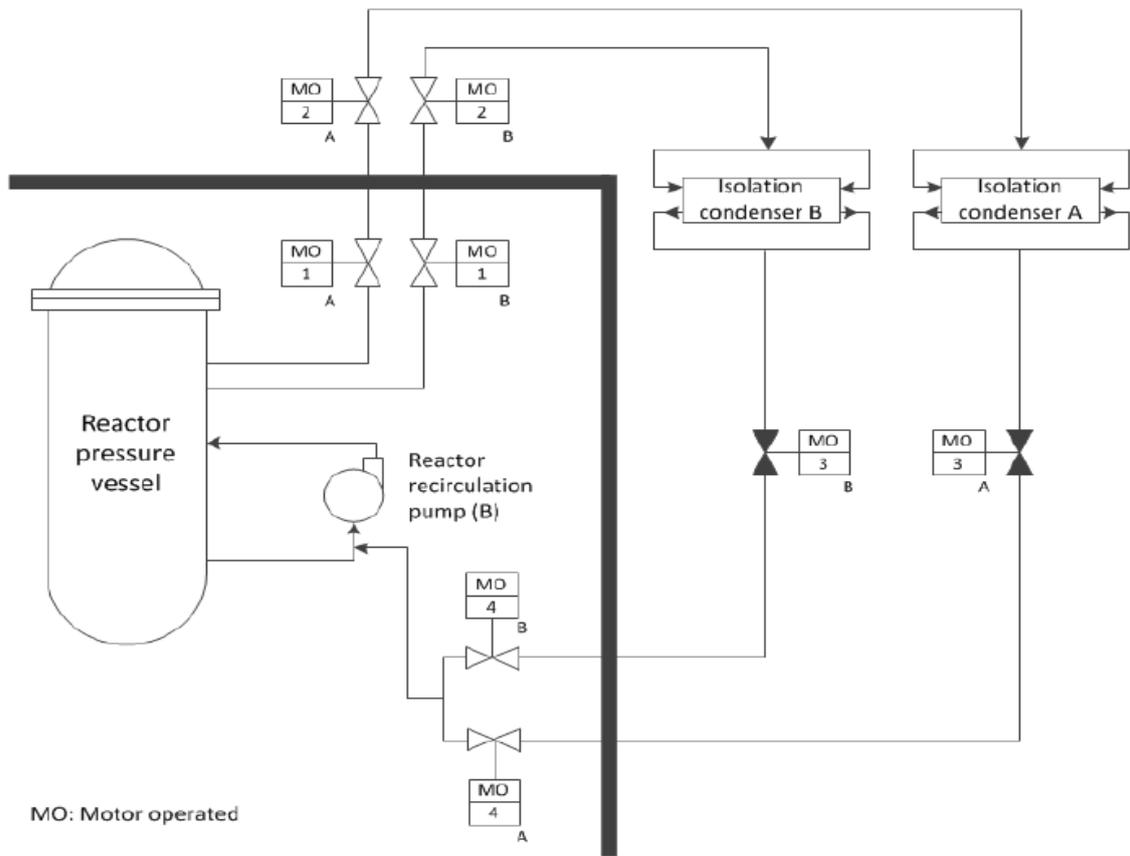
Fig. A4 Schematic of Isolation Condenser (IC) [A4-1]

Fig. A4 shows a schematic diagram of the IC and its piping system installed in Unit 1 [A4-1]. Two IC trains named A and B were installed to cool the reactor core. Each of them has four isolation valves 1A to 4A and 1B to 4B, respectively. Just after the earthquake, both trains started working at the same time. This meant that all the valves were opened automatically as a result of the fail-safe function. But since the cooling capacity was too big to keep the cooling rate within the prescribed limit, that is, $55^{\circ}\text{C}/\text{hour}$, the operator closed the isolation valve, 3B, which meant that the B-train did not work afterwards. Then the operator repeated closing and reopening isolation valve 3A of the A-train three times by following the suggestion in the operation manual. This was done to keep the cooling rate within the prescribed limit. These operations were done to prevent the generation of the excess thermal stress. The operations and the behaviors of the IC described above suggested that the IC was working normally and there was no evidence which showed a failure of the piping system as could be regarded as an LOCA.

There was a complicated problem associated with the fail-safe function of the IC. In the following only the behavior of the valves in the A-train are explained because the B-train has the same function. In the train the control signals for the fail-safe function were driven by the DC power supply, and the AC power supply was necessary to open and close valves 1A and 4A which were located inside the PCV, while the DC power supply was necessary for valves 2A and 3A located outside the PCV. If both AC and DC power supplies were available and the isolation signal was sent, all the valves would have been closed automatically as a result of the fail-safe function. But, when the sea water flooded the distribution panel, the order of the function loss of the AC and DC power supplies was unknown. In the first case, if the DC power supply had failed first and the AC power supply was available for a while, the valves 1A and 4A would have been closed while 2A and 3A were kept

open, just as they were before the tsunami struck. In the second case, if the AC power supply had failed first and the DC power supply was available for a while, the valves 2A and 3A would have been closed while 1A and 4A were kept open.
